# BERHAMPORE KINDERGARTEN, WELLINGTON

Conservation Plan

## CONSERVATION PLAN

MHST 522 Historic Heritage Conservation

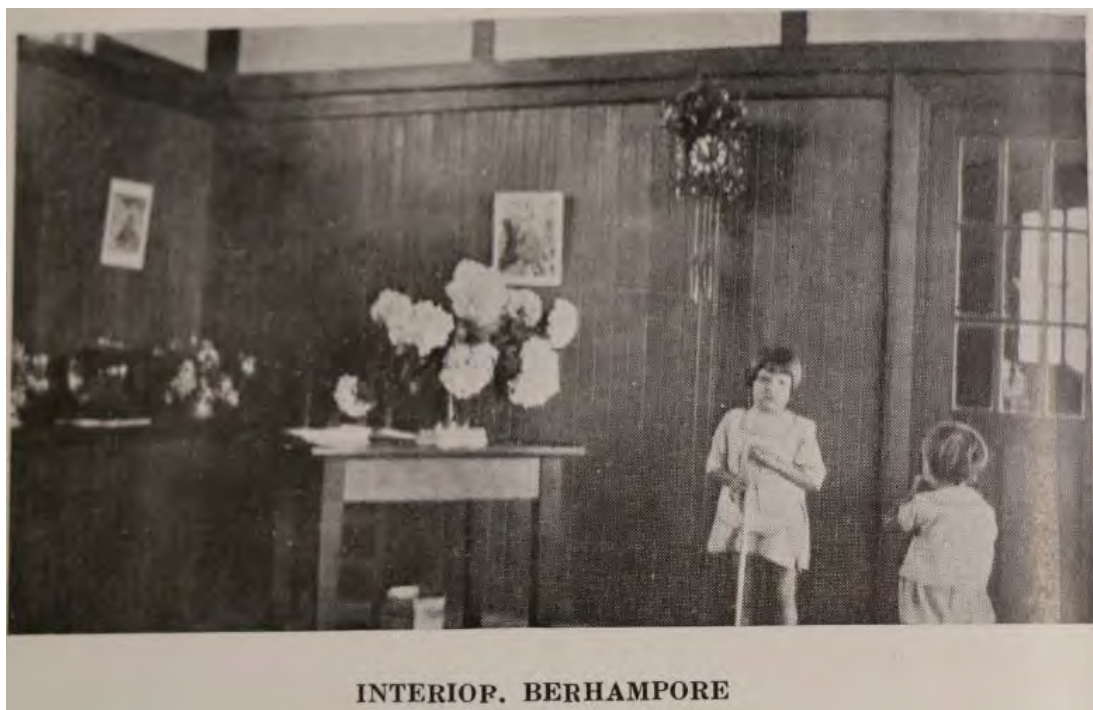
Figure 9: The interior of Berhampore Kindergarten, 1929. Photographer unidentified. Source: Wellington Free Kindergarten Association, *Report for the Year Ended 31<sup>st</sup> March 1929* (ATL MS-Papers-4105-10).

Inside, the kindergarten featured a main room with a high beamed ceiling, casement windows along the northern elevation, and a large brick fireplace that was pointed in white cement, decorated with shingle tiles, and had a cement hearth with nine inch fender walls. The tongue and groove floorboards were matai, some interior walls featured tongue and groove lining, and the interior doors were of rimu. The bathroom was painted but elsewhere woodwork was oiled and stained. Two panelled doors with glazed upper panels opened into the kindergarten from the hall. There was a service hatch between the kitchenette and main room, and other built-in features included a folding table in the kitchenette and window seats with storage underneath.<sup>44</sup> The building was praised for its light, airy spaces, and cross ventilation at the time of its opening, but the playground was not to be completed until sometime later.<sup>45</sup> The room to be used for the youngest group, the Babies' Room, was built by legacies left by Miss Anne Greenwood and Miss Sylvia Stowe. Other donations included furniture, a cuckoo clock, and a tea urn.<sup>46</sup>

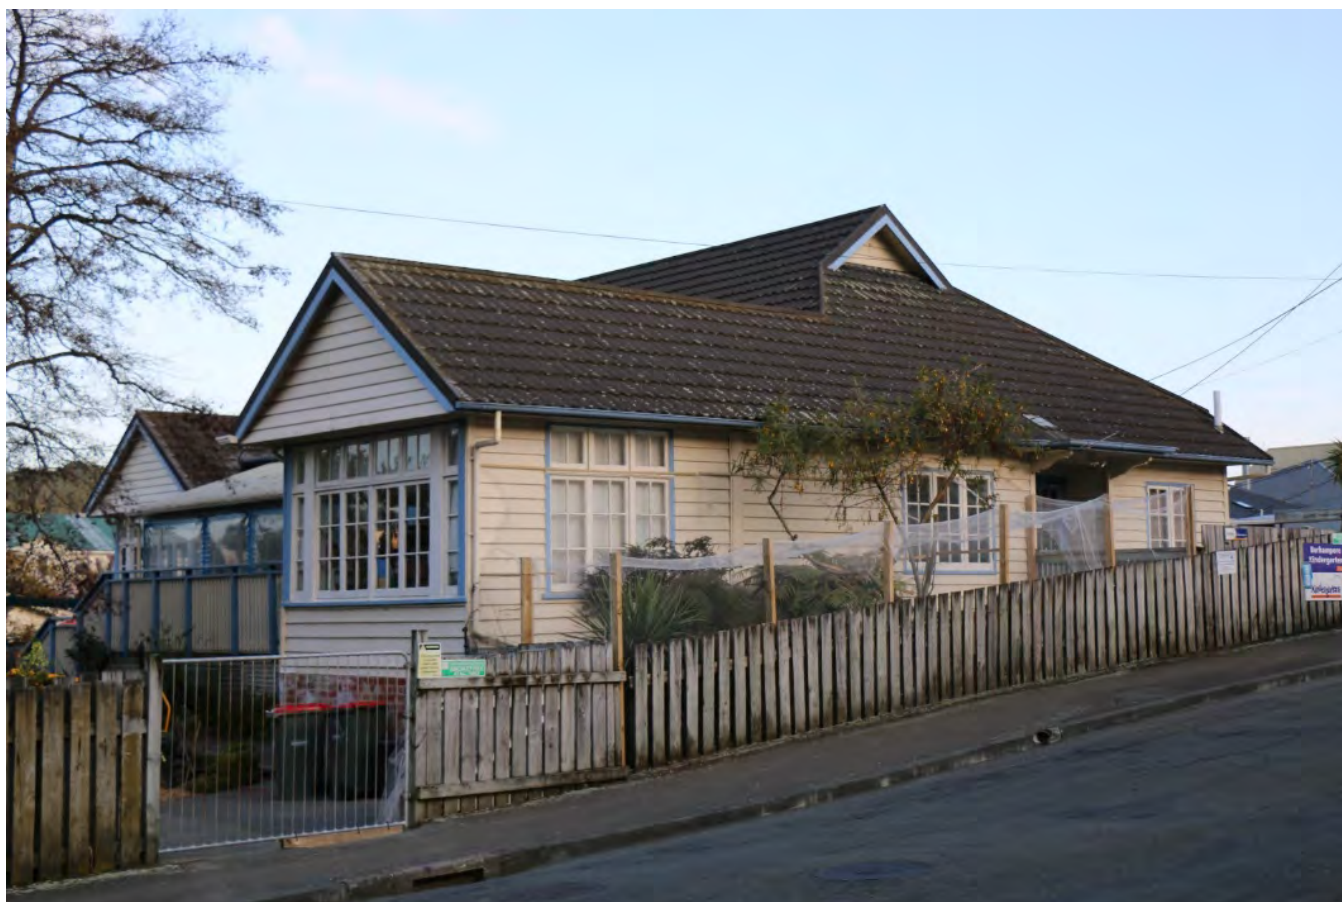
## West elevation

Overall rank – 2

Element	Fabric	Rank
Cladding	Bevel back timber weatherboards, corner boards, bargeboards	2
Spouting	PVC gutters and downpipes	0
Deck	Timber decking and balustrade	0
Foundation stone	Marble	2
Foundation wall	Brick and mortar	2
Porch roof	Timber including corbels	2
Doors	Timber, each with nine lights	0
Windows	Timber casement windows with nine lights; fanlights with two lights; timber sills and scribes	2

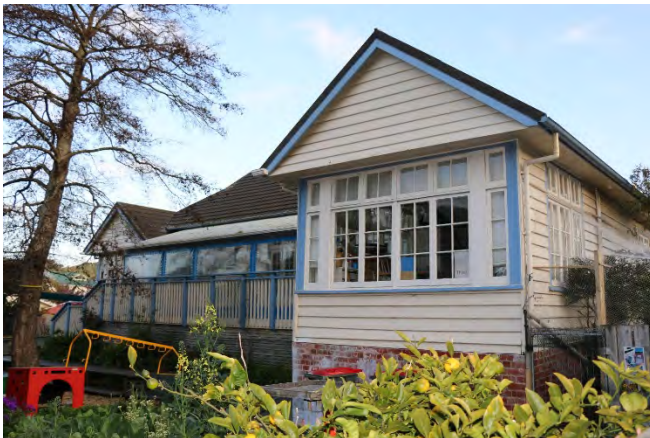
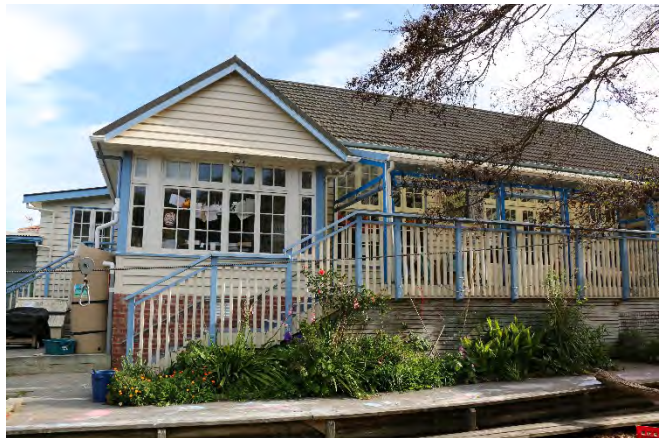
## North elevation

Overall rank – 2

Element	Fabric	Rank
Cladding	Bevel back timber weatherboards, corner boards, bargeboards	2
Spouting	PVC gutters and downpipes	0
Verandah	Timber balustrade, steps and decking; corrugated acrylic; PVC	0
Foundation wall	Brick and mortar	2
Door	Timber with eight lights; brass letterbox	2
Doors	Timber bi-fold with eight lights	0
Doors	Tongue and groove timber doors in foundation wall	1
Windows	Mullioned windows with four lights (not original)	0
Windows	Timber casement windows with three or nine lights; fanlights with one or two lights; original mullioned windows with four lights; timber sills and scribes	2

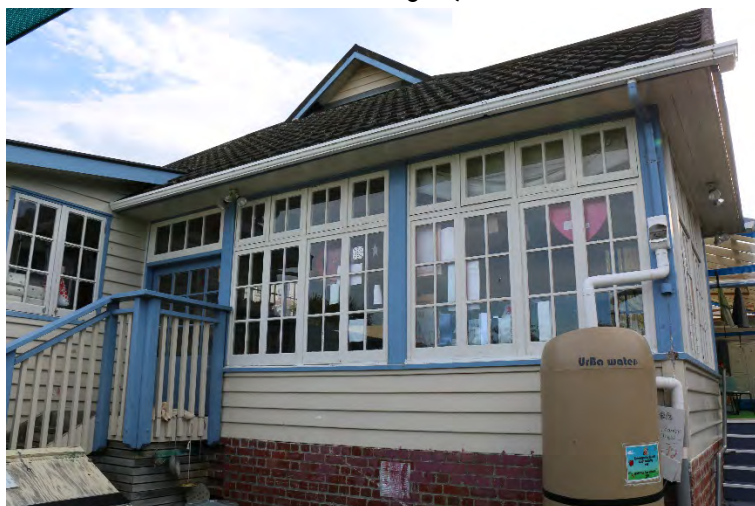
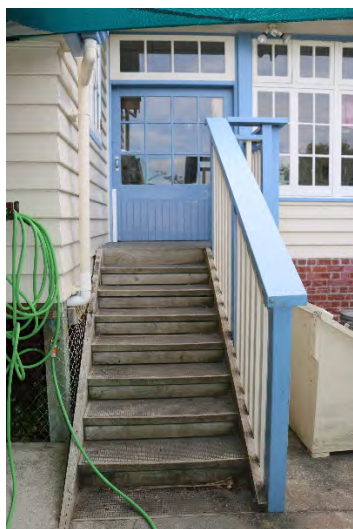
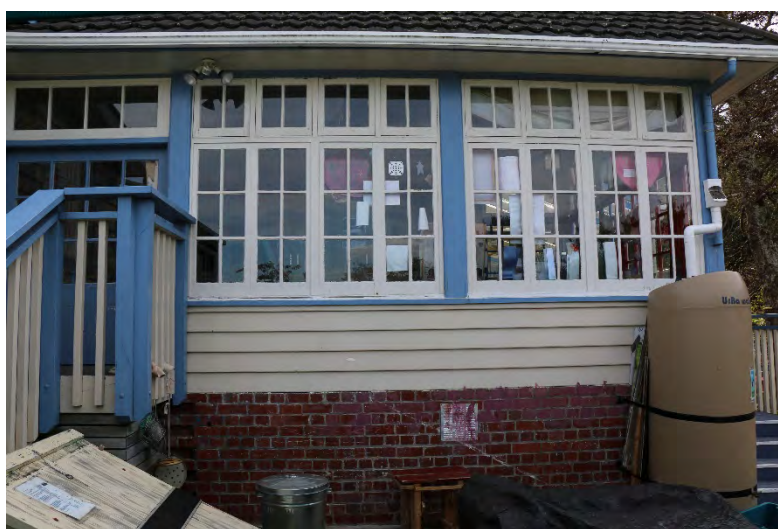
## East elevation

Overall rank – 2

Element	Fabric	Rank
Cladding	Bevel back timber weatherboards, corner boards, bargeboards	2
Spouting	PVC gutters and downpipes	0
Foundation wall	Brick wall and mortar	2
Foundations	Timber, wire netting	0
Steps	Timber balustrade, steps and decking	0
Door	Timber sliding door with twelve lights	2
Windows	Timber casement windows with nine lights; fanlights with two lights; mullioned window with four lights; timber sills and scribes	2

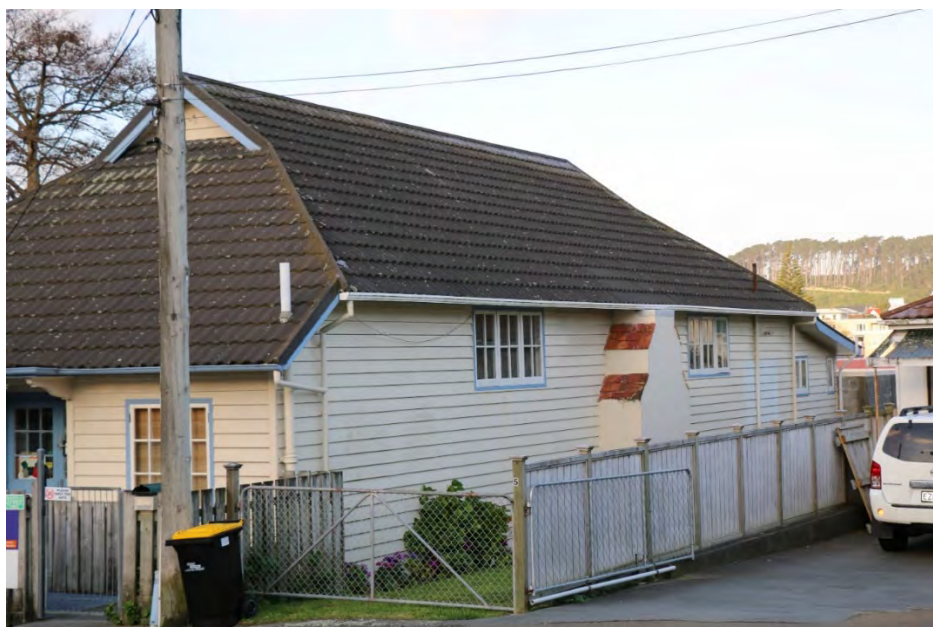
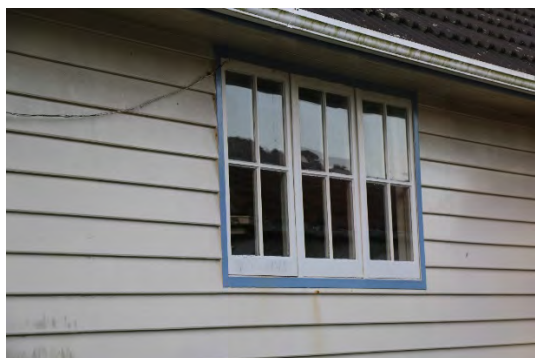
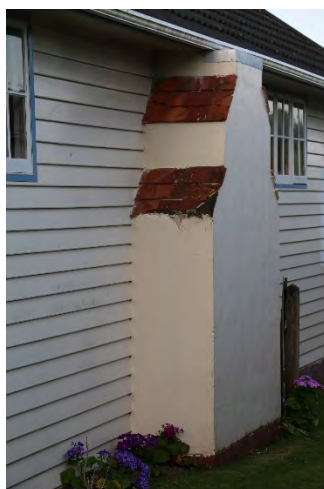
## South Elevation

Overall rank – 2

Element	Fabric	Rank
Cladding	Bevel back timber weatherboards, corner boards	2
Spouting	Gutters and downpipes (PVC)	0
Spouting	Downpipes (metal)	2
Foundation wall	Brick and mortar	2
Chimney	Plastered with shingle tiles, metal trim	1
Windows	Timber casement with one or four lights; timber sills and scribes	2

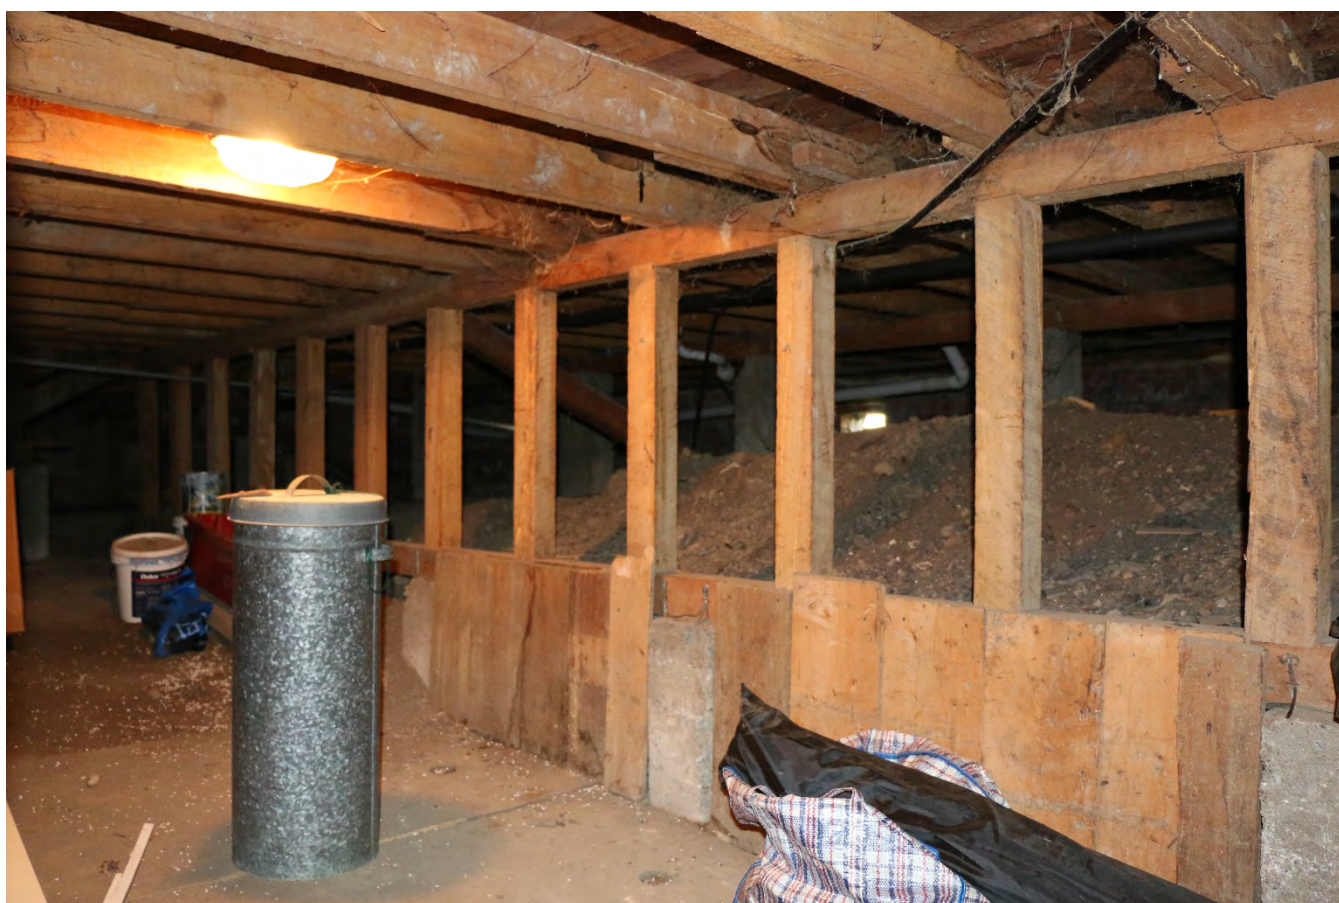
## Sub-floor and foundations

Overall rank – 2

Element	Fabric	Rank
Piles	Concrete, timber	2
Foundation wall	Brick and mortar	2
Bearers	Timber	2
Floor joists	Timber	2
Retaining wall	Timber	0

The main part of the building requiring stabilisation is the foundation wall on the northwest corner, which shows evidence of subsidence.

Subsidence has been caused by deterioration in the ground. The solution would need engineering input and is likely to include repair to the foundation wall and some form of ground stabilisation, for instance, piling or concrete foundations.

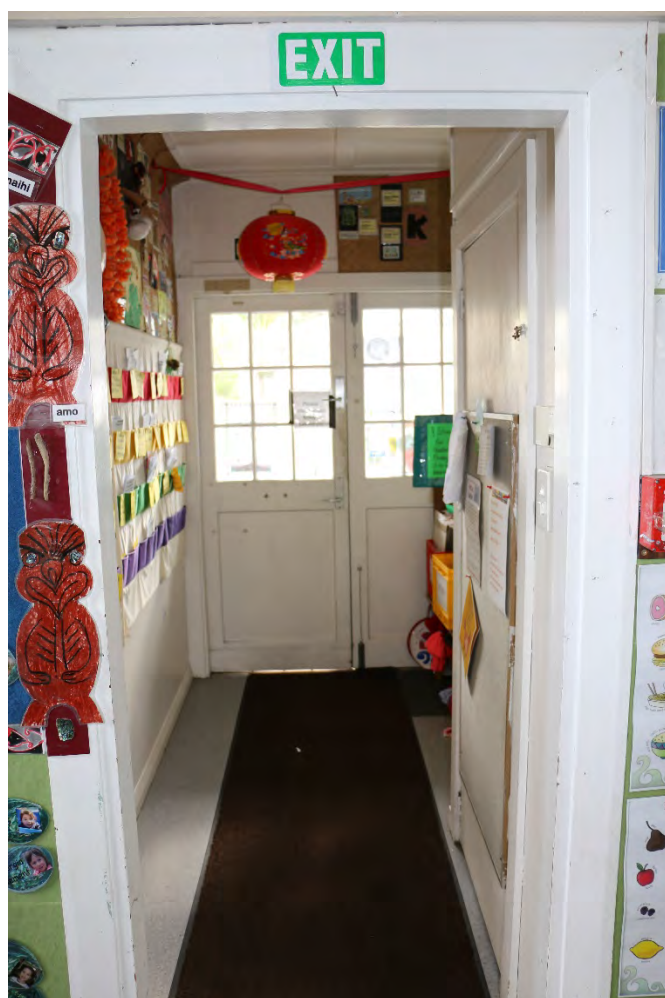
## Block room

Overall rank – 2

Element	Fabric	Rank
Ceiling	Timber panelling, manhole cover and framing	2
Walls	Timber panelling, picture rail	2
Walls	Plasterboard	0
Flooring	Carpet on original timber	1
Skirting	Timber	0
Light fitting	Fluorescent batten	0
Window	Timber architrave, metal latches ( <i>See also West Elevation</i> )	2

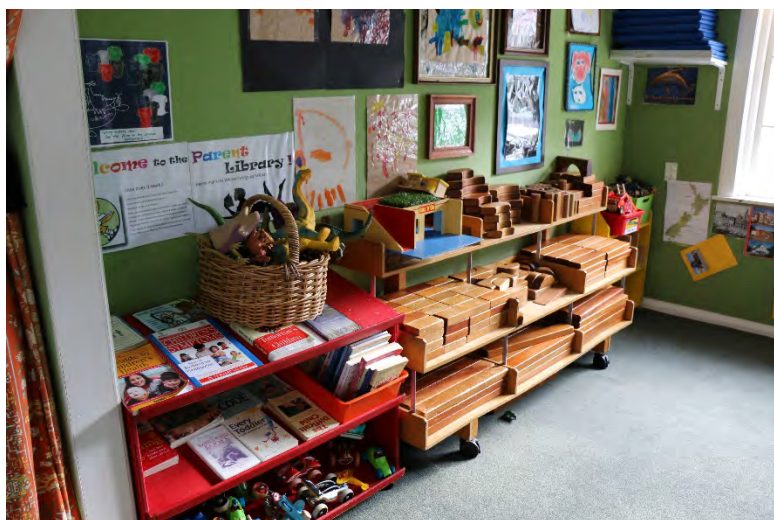
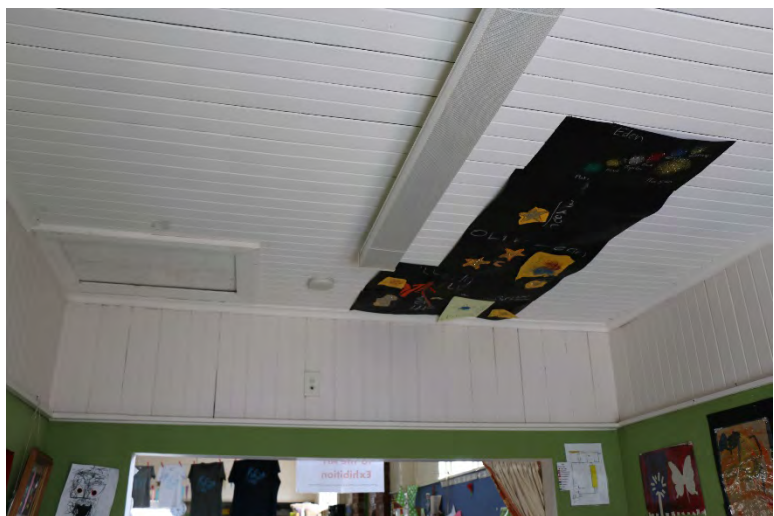
## Cloakroom

Overall rank – 2

Element	Fabric	Rank
Ceiling	Panelled with timber battens	2
Walls	Timber panelling	2
Flooring	Vinyl on original timber	1
Skirting	Timber	0
Light fitting	Fluorescent batten	0
Viewing windows	Glass, timber architraves	0
Window	Timber architrave, metal latches (See also West Elevation)	2

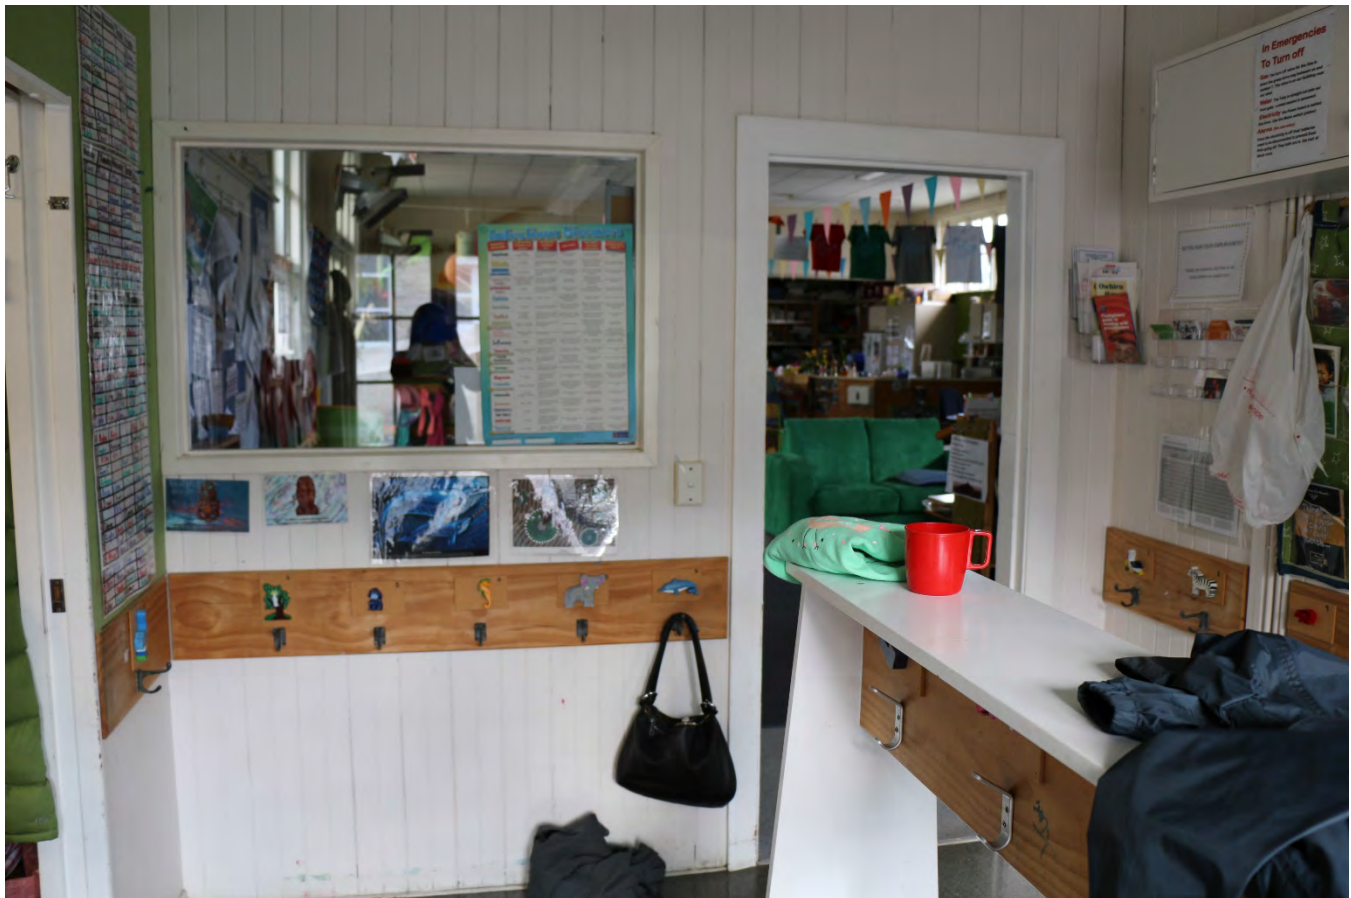
## Office

Overall rank – 2

Element	Fabric	Rank
Ceiling	Panelled with timber battens	2
Walls	Plasterboard	0
Walls	Timber panelling	2
Flooring	Carpet on original timber	1
Skirting	Timber	0
Light fittings	Fluorescent batten	0
Door	Timber slider and architrave	0
Windows	Timber architraves, metal latches (See also West & North Elevations)	2

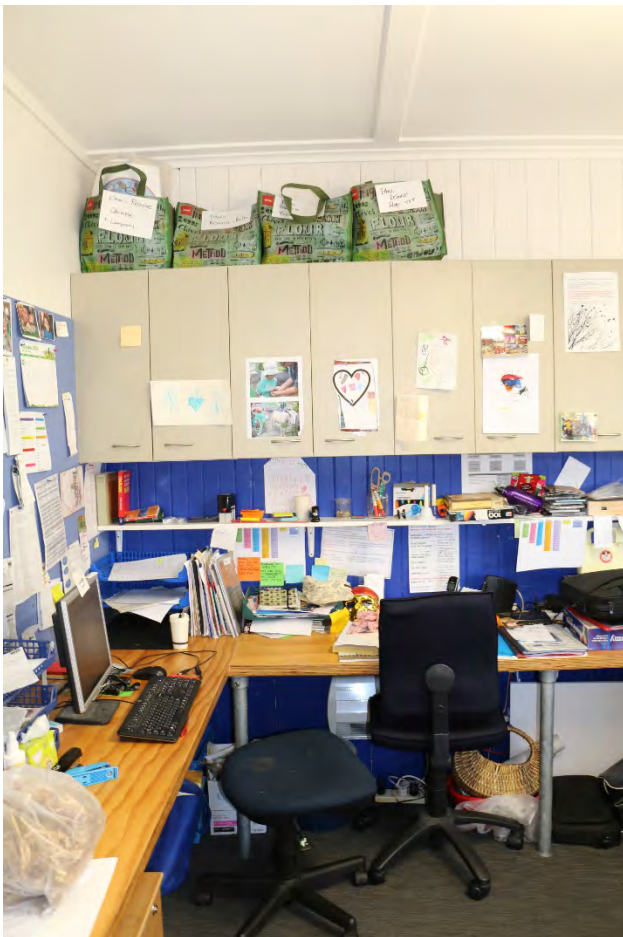
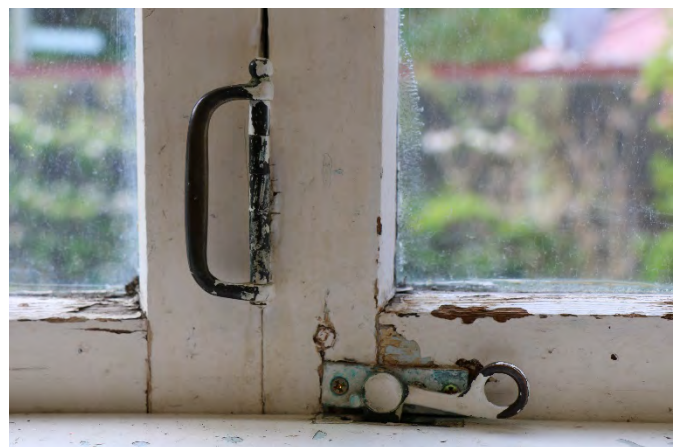
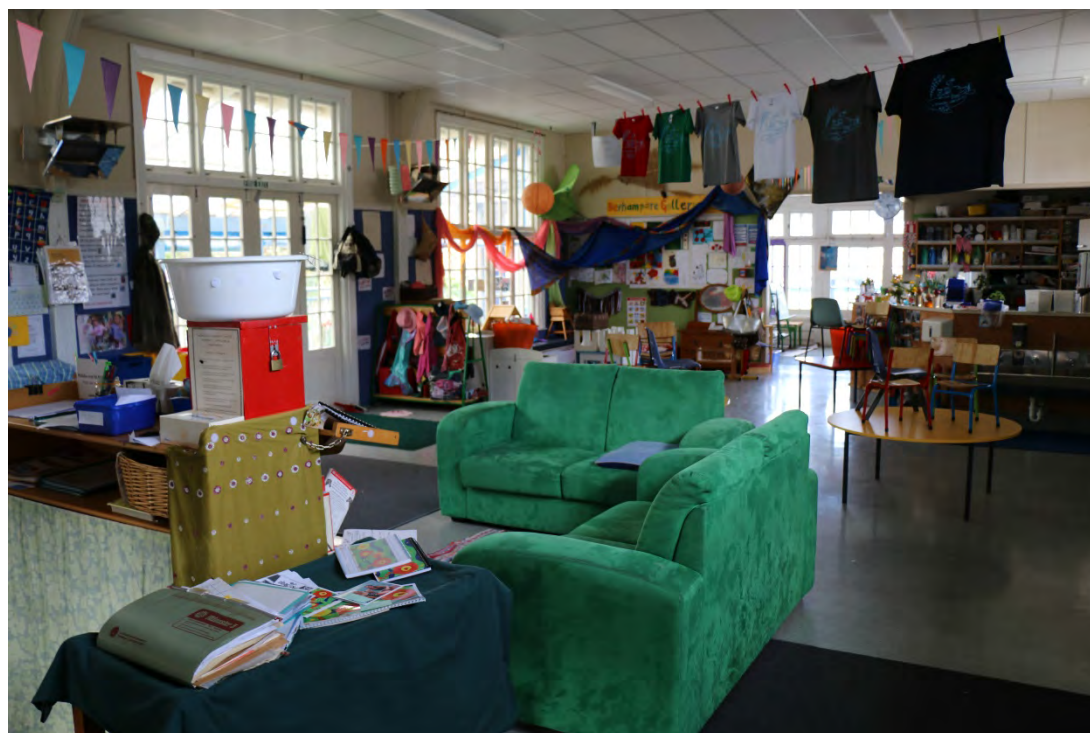
## Main room

Overall rank – 2

Element	Fabric	Rank
Ceiling	Soundproof tiles in lowered ceiling	0
Ceiling	Original panelling with timber battens and arches	2
Walls	Plasterboard, Autex	0
Walls	Plasterboard; timber battens and picture rail	2
Flooring	Vinyl on original timber	1
Skirting	Timber	0
Light fittings	Fluorescent batten	0
Fireplace	Timber, plaster, brick and mortar, tiles	2
Doors	Timber architraves, metal latches ( <i>See also North Elevations</i> )	0
Windows	Timber architraves, metal latches ( <i>See also South &amp; North Elevations</i> )	2
Window seat	Timber panelling and board	2
Kitchen	Timber, metal fittings and fixtures, laminated benchtops	0

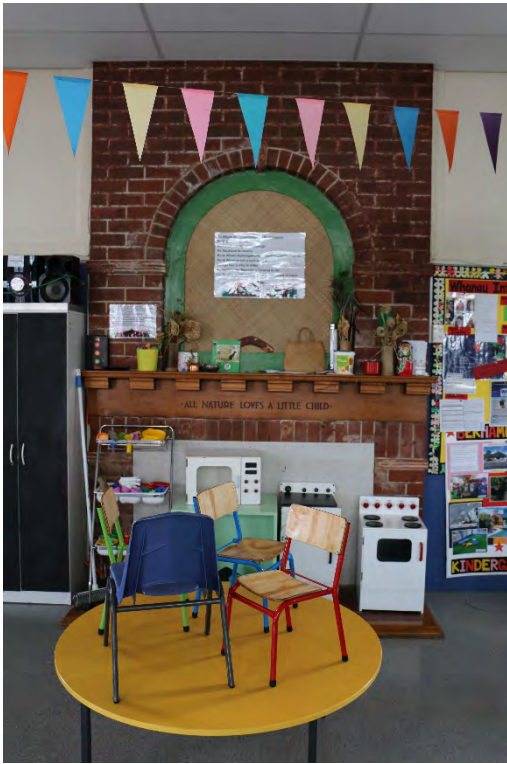
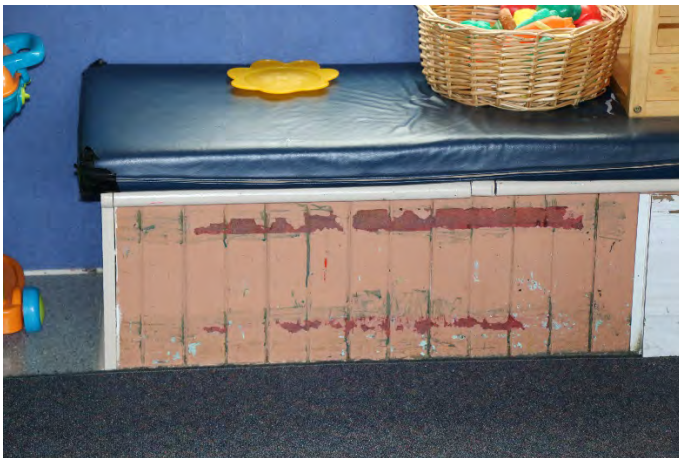
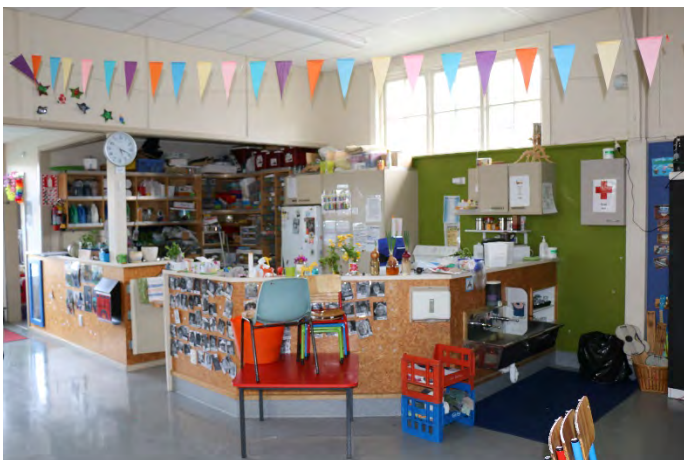
## Art area

Overall rank – 1

Element	Fabric	Rank
Ceiling	Soundproof tiles in lowered ceiling	0
Ceiling	Original ceiling	2
Walls	Bevel back timber weatherboards	2
Walls	Plasterboard	0
Flooring	Vinyl on original timber	1
Skirting	Timber	0
Light fittings	Fluorescent batten	0
Cupboards	Timber; metal handles	0
Windows	Timber architrave, metal latches ( <i>See also East &amp; North Elevations</i> )	2
Door	Metal runner ( <i>See also East Elevation</i> )	1

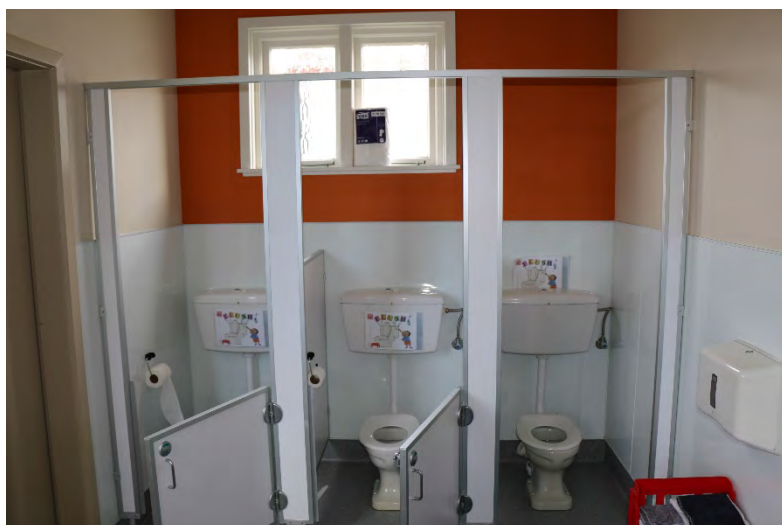
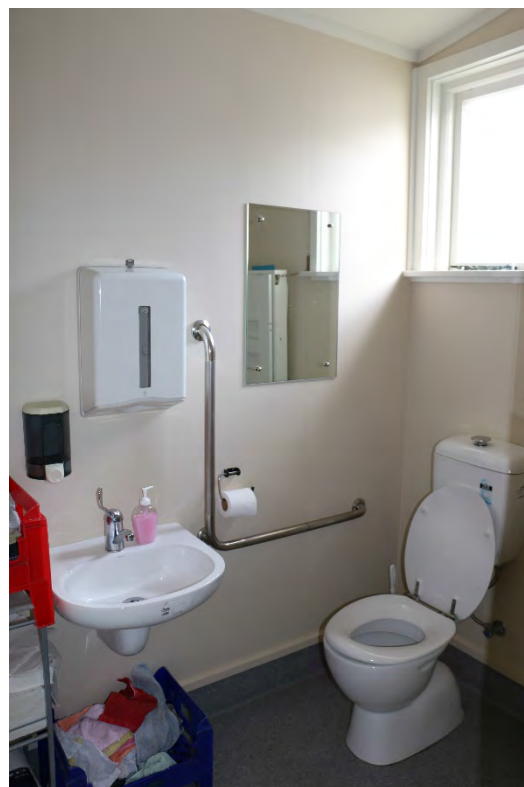
## Chattels

Overall rank – 2

Element	Fabric	Rank
Commemorative stone	Marble	2
